| Material Type: | Synthetic Turf |
| Material ID: | Platinum Putt |

| Standard: | FIFA Section 17 | Test Method: | Procedure for Simulated Mechanical Abrasion |
| Standard: | EN 15336 | Test Method: | Surface for Sports Area, Exposure for Synthetic Turf to Simulated Wear (LiSport) |

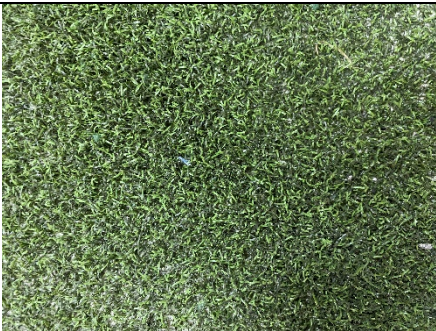
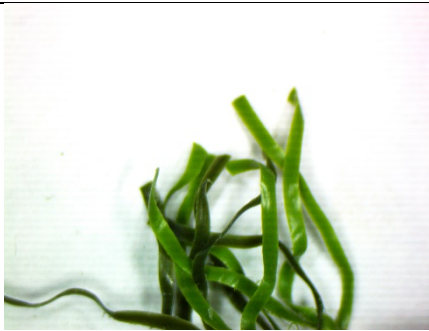
APPENDIX A: Camera and Microscopic View of Fibers

| Prior to any LiSport Exposure | | |

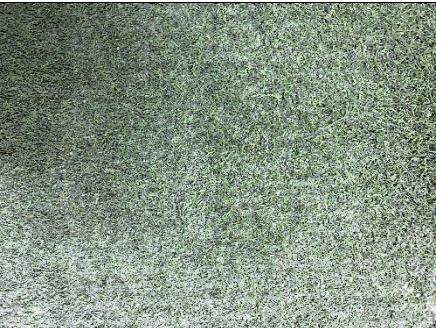
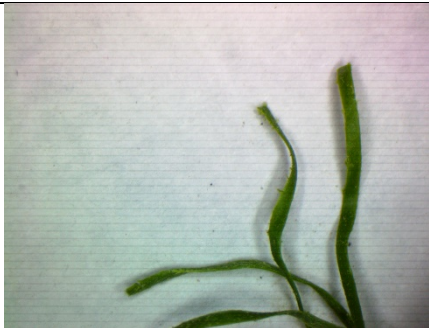
Infill dispersion and tuft loss was slight for the entire test duration. Fiber splitting was negligible. Pile flattening was very moderate.

| After 1,000 Cycles of LiSport Exposure | | |

| # of Cycles | Infill Dispersion | Tuft Loss | Pile Flattening | Fiber Splitting |
|---|---|---|---|---|
| 1,000 | 2.0 | 1.5 | 3.5 | 1.0 |
